Manhole Inspection Summary

Manhole # S39UU_013MH

Insp Date: **12/19/06 12:36 PM**

Location Address: **1001 REESE ST** Cross Street: **EXETER HALL AVE**

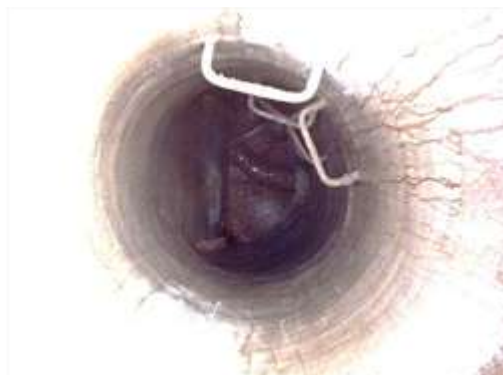
Top View

Adjustment and Barrel infiltration. Bench debris.

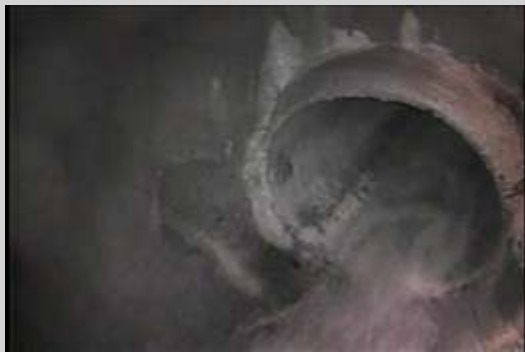
21 in. Circular Gravity Sewer Pipe Out @ 12 O'Clock

Deposits: ☒ None ☐ **Mud** ☐ Sludge ☐ **Debris** ☐ **Grease**

Infiltration: **None** Pipe Seal Cond: **Unknown**

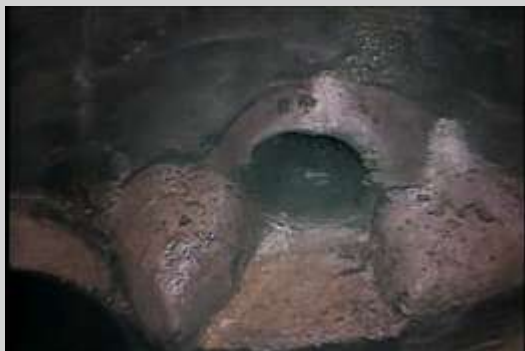
8 in. Circular Gravity Sewer Pipe In @ 2 O'Clock

Deposits: ☒ None ☐ **Mud** ☐ Sludge ☐ **Debris** ☐ **Grease**

Infiltration: **None** Pipe Seal Cond: **Sound**

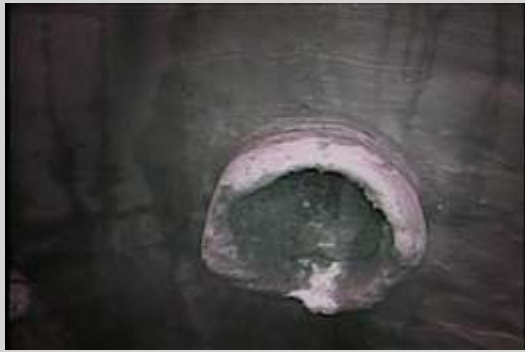
Pipe In @ 3 O'Clock

Deposits: ☐ None ☒ Mud ☐ Sludge ☒ Debris ☒ Grease

Silt Depth: **6** (in.) Deposits Extent: **Heavy**

Infiltration: **Evidence**

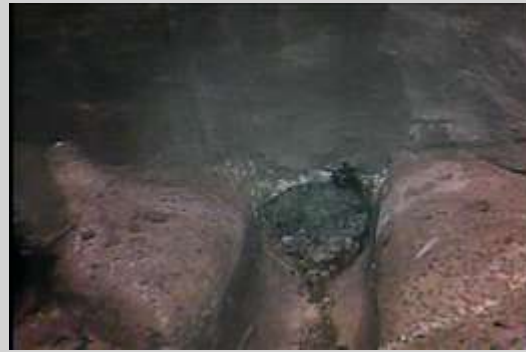
Drop In @ 3 O'Clock

Drop: **Outside** Rod and Bar

Drop Condition: **Clogged**

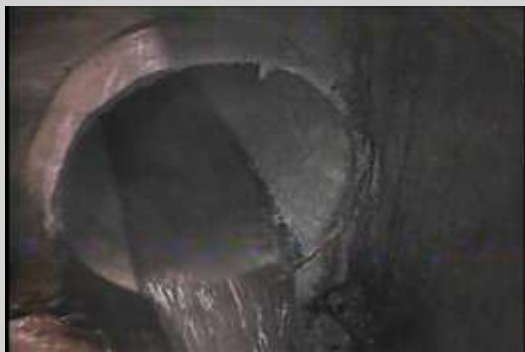
Pipe In @ 6 O'Clock

Deposits: ☒ None ☐ Mud ☐ Sludge ☐ Debris ☐ Grease

Infiltration: **None**
